NASA Project Mercury Working Paper No. 192

POSTLAUNCH REPORT

MERCURY-REDSTONE NO. 3

June 16, 1961

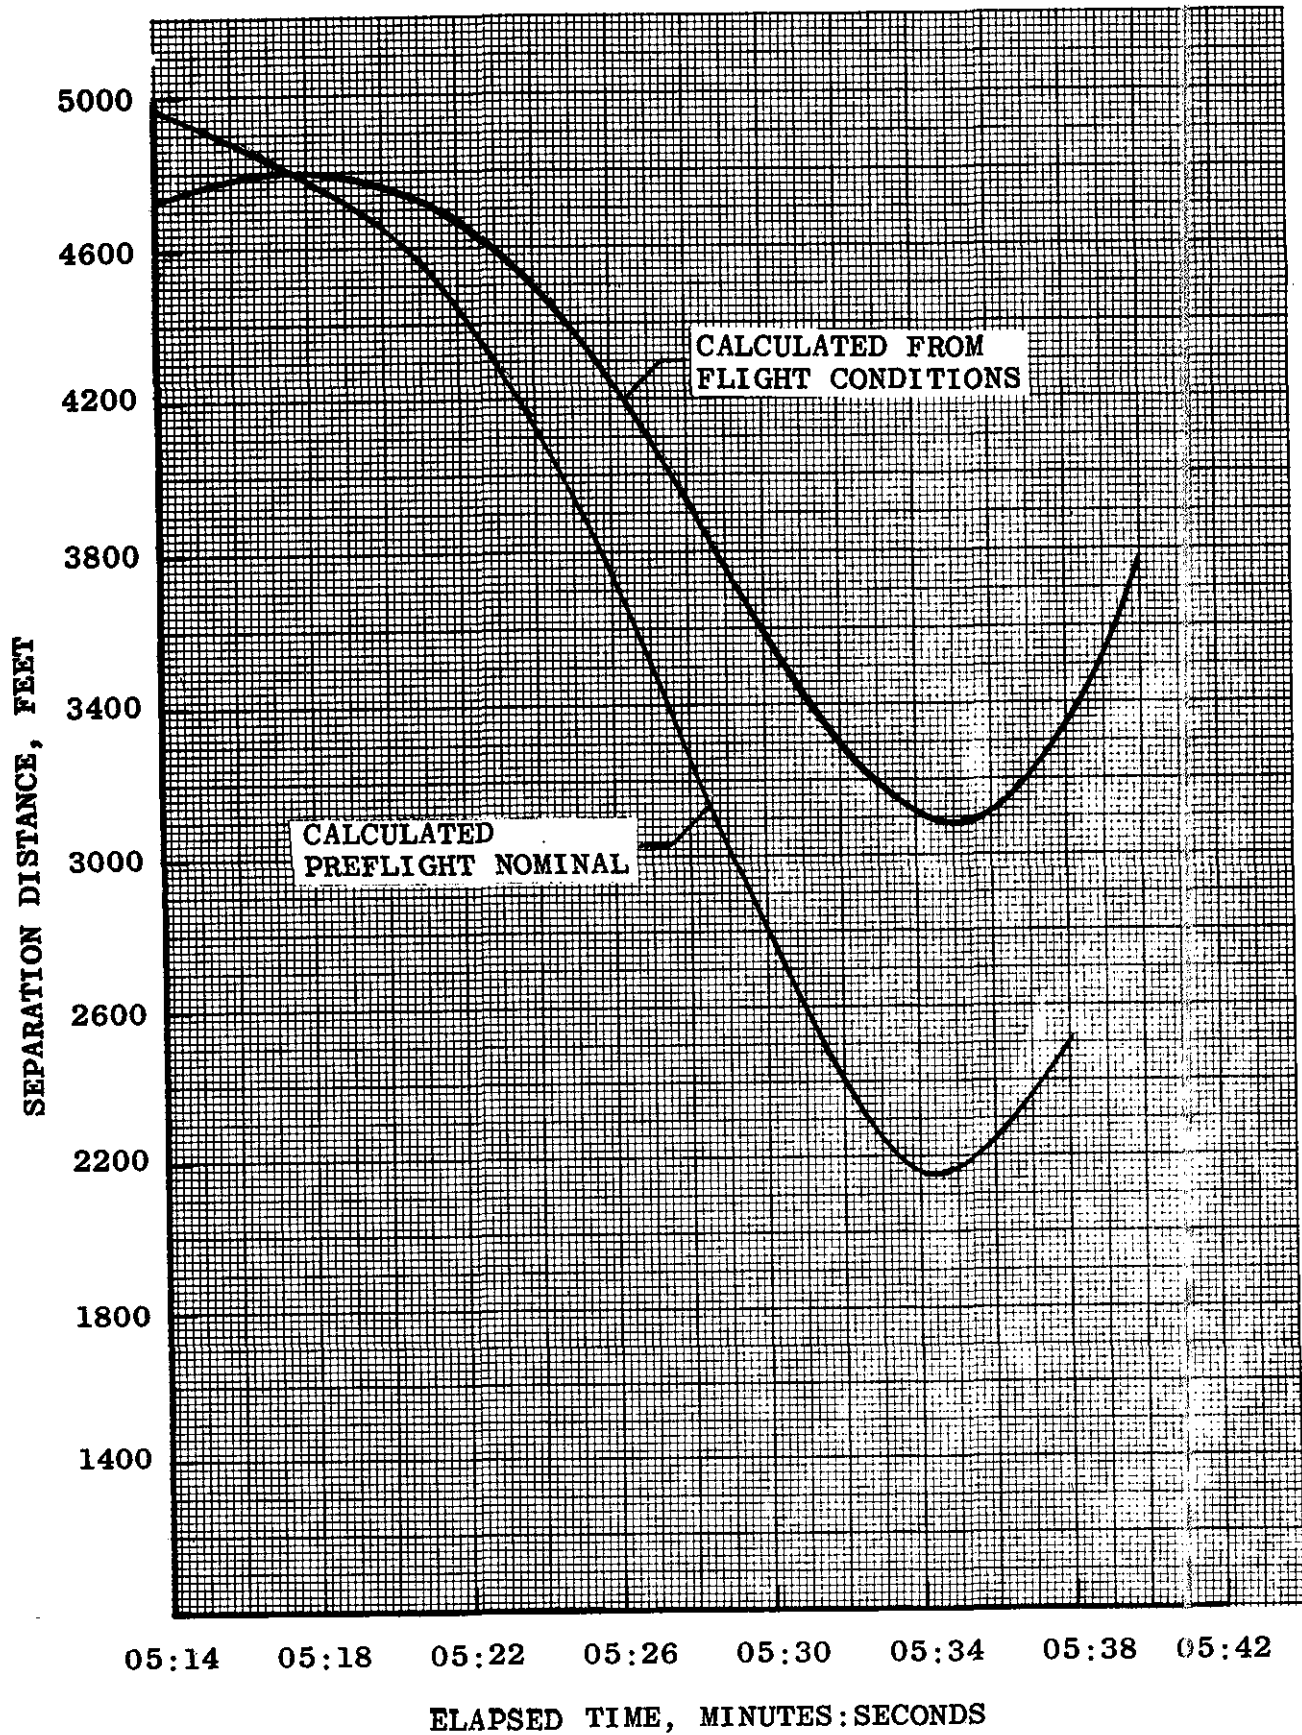
FIGURE 4.2-9.- TIME HISTORY OF SEPARATION DISTANCE BETWEEN CAPSULE  
AND BOOSTER DURING RETROFIRING.

A preliminary analysis of the AZUSA MK II tracking data and the Cape 1.16 radar data indicated that the post-boost rocket performance was about as expected. The separation velocity was approximately  $30 \pm 3$  feet per second. Although the radar tracking data during retrofiring was noisy, the inertial velocity decrease along the flight path was measured to be approximately  $390 \pm 30$  feet per second. The computed velocity decrease along the flight path for this capsule, with a nominal total impulse along the body axis and an average retro-attitude angle of 20 degrees above the local horizontal, is approximately 420 feet per second. This computed value is within the reading accuracy of the measured value.

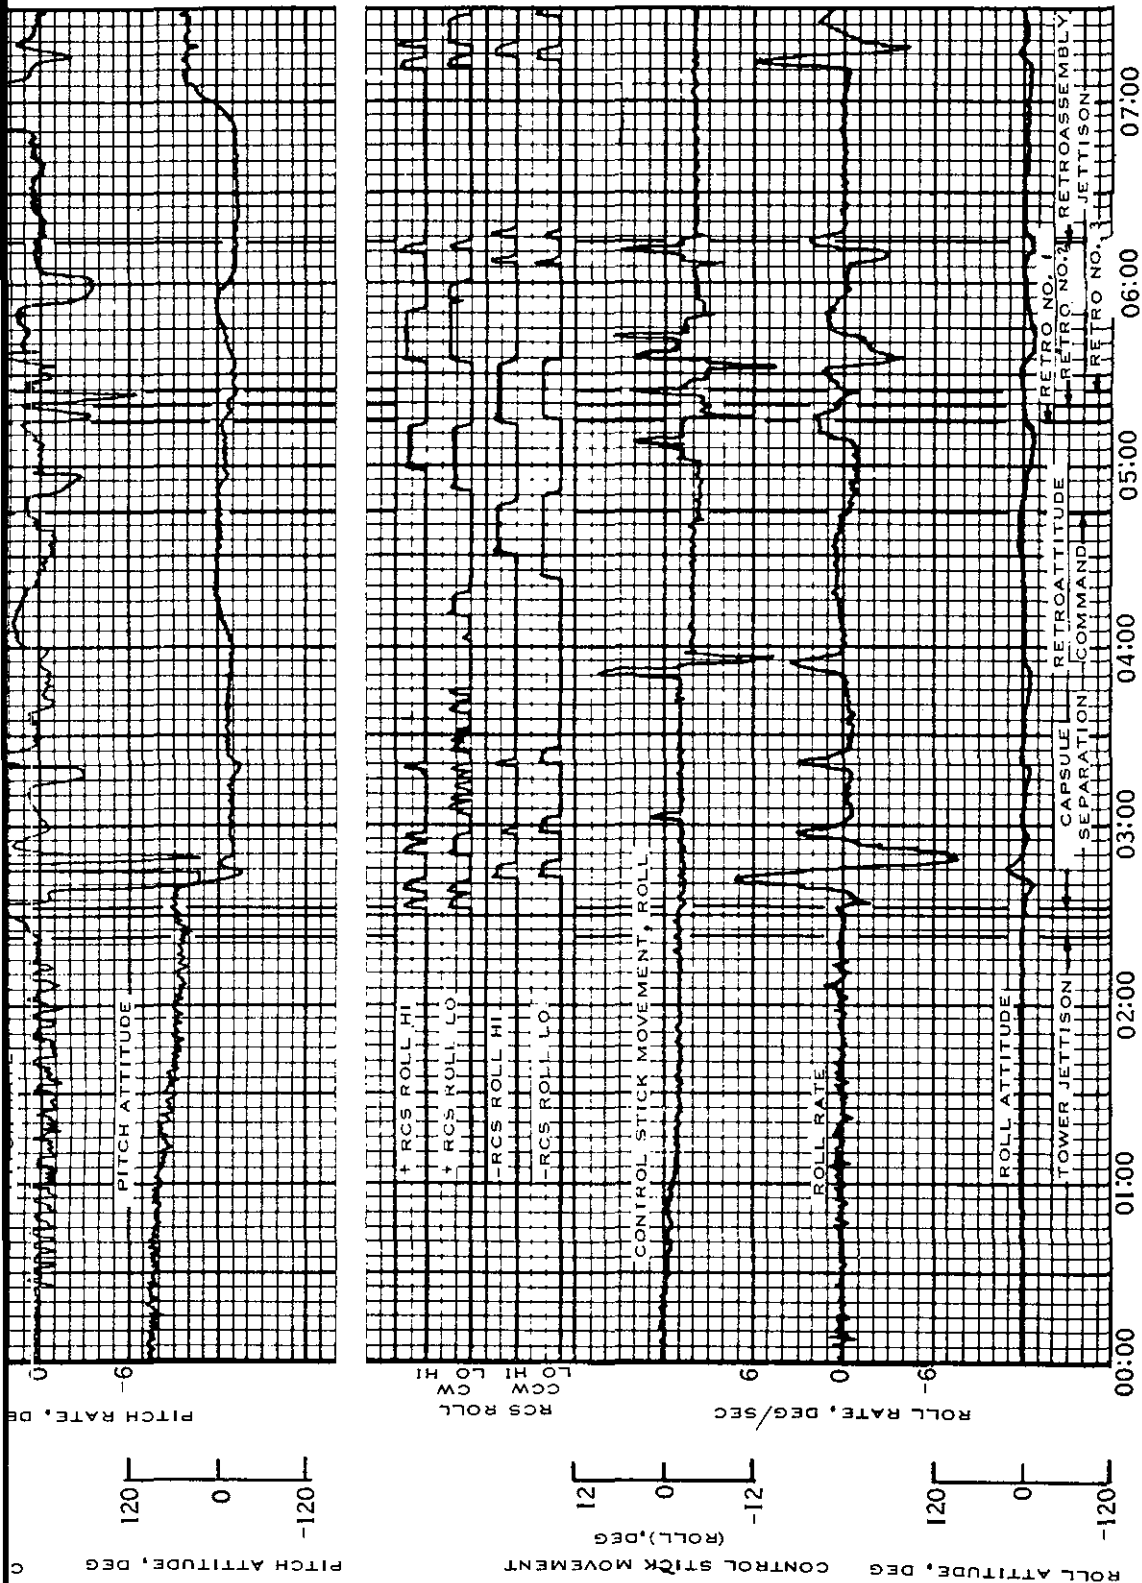
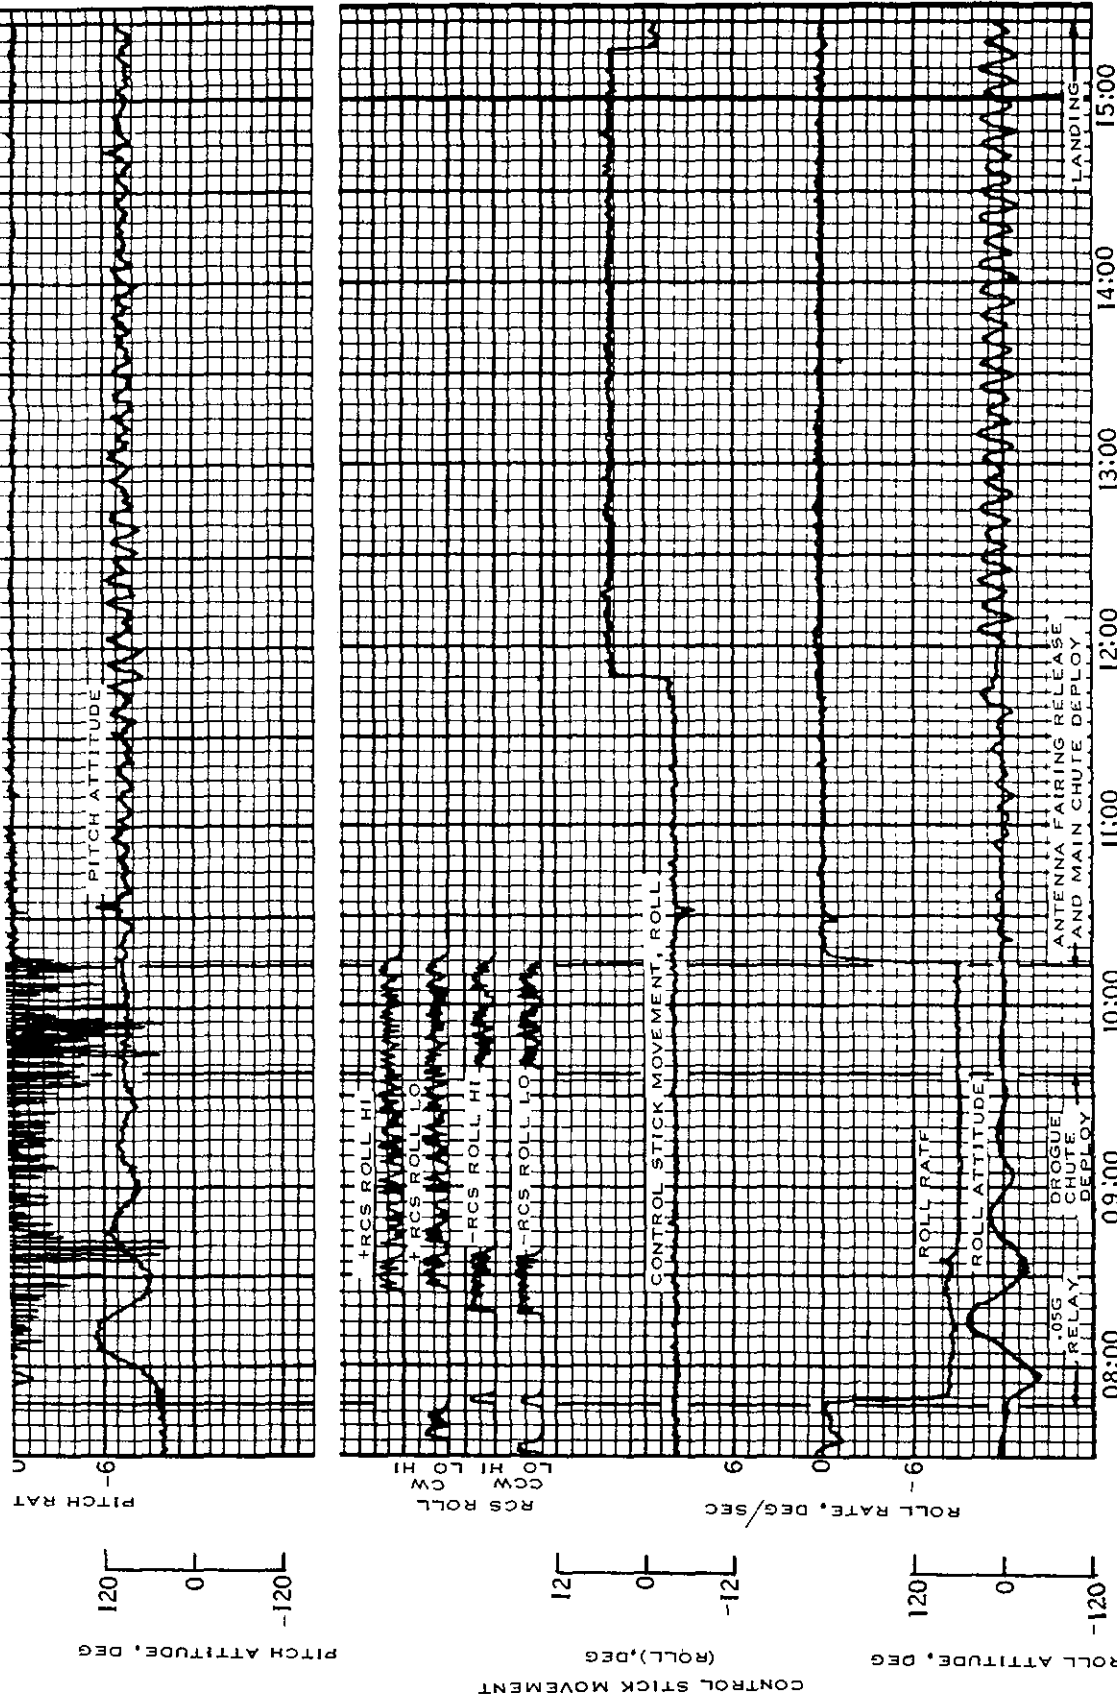
FIGURE 5.2-2 CONTROL SYSTEM PERFORMANCE

The performance of the control system is shown on Figure 5.2-2, and is discussed in the following paragraphs. The performance of the pilot in exercising manual control is dealt with in Section 7.3.3.

Between 02:32 and 03:04, 5 seconds of rate damping followed by the turnaround to orbit attitude were accomplished as planned. The slight excursions observed during the turnaround maneuver were well within the expected limits.

Between 06:07 and 06:18 a checked roll command was made. Capsule motions and solenoid actions were all in the expected sequence. However, detailed analysis of the records has shown that the rates involved were substantially less than those produced by the solenoid action noted in other segments of the flight when the ASCS was in the automatic mode.

It was also noted that none of the rates obtained about any axis during the whole period in question exceeded that corresponding to a single high thruster. This behavior could be explained if the automatic fuel was not turned on or only partly turned on. However, it is much more likely that it is due to the manual blips being of much shorter duration than the ASCS blips. It should be noted that the length of the pulses cannot be obtained from the instrumentation records because the solenoid pulses are first fed through a holding circuit and then commutated before being recorded. Thus there is no direct evidence of the duration of the solenoid pulses.

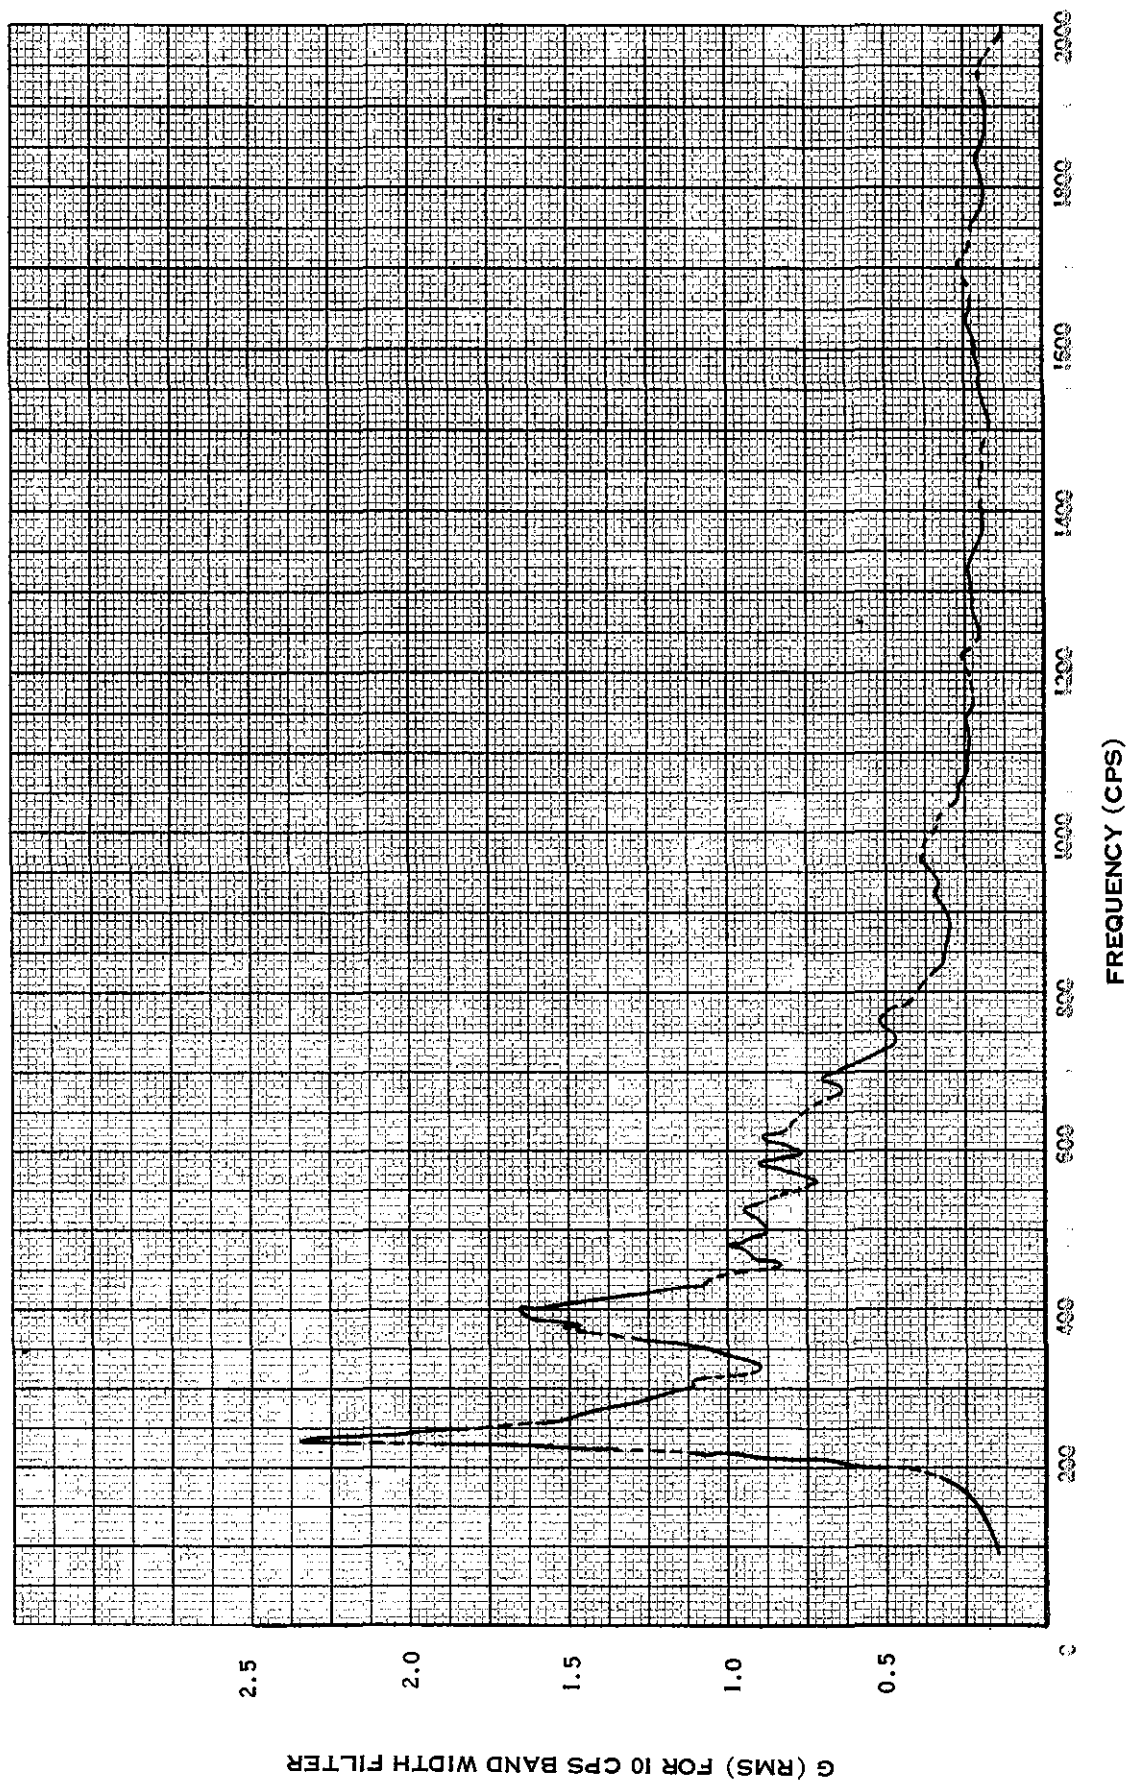
FIGURE 6.0-1.-SPECTRAL ANALYSIS OF VIBRATION AT ADAPTER AT 01:10.

A 30g accelerometer was located inside of the adapter section adjacent to the capsule adapter clamp ring. This instrument was used to measure radial vibration in this area and was monitored through the booster telemetry system. The maximum amplitude of the composite wave form as read from the telemetry trace was approximately 11g and occurred between 01:10 and 01:25. A spectral analysis of this vibration as furnished by the Marshall Space Flight Center is shown in Figure 6.0-1. Not shown on this figure is a vibration of low magnitude (about 0.14g) occurring at 33 cps, which is near the second longitudinal mode of the booster.
